Radiant Heater RH600
Technical Service Bulletin # 4

Re.: **Replacement of swivel bearing 2M 18 652 of RH600**

Update: August 24, 2000

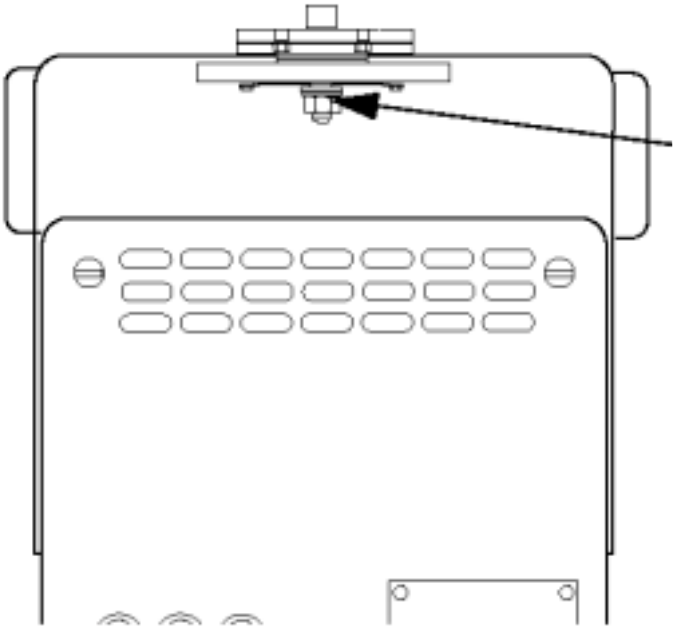
Reason: To ensure the swivel bearing version with one nut does not become loose.

Solution: Installation of a newer version with 2 nuts P/N 2M 18 652 or P/N SE 2M 18 652.
